XRF LEAD SURVEY REPORT

(McDONALD DOUGLAS)
(BONEYARD BUILDINGS 54, 55, 56)

July 1, 1998
Project No. ES98-038

LEAD PAINT TESTING REPORT
McDONALD DOUGLAS
BONEYARD BUILDINGS 54,55,56
TORRANCE, CALIFORNIA

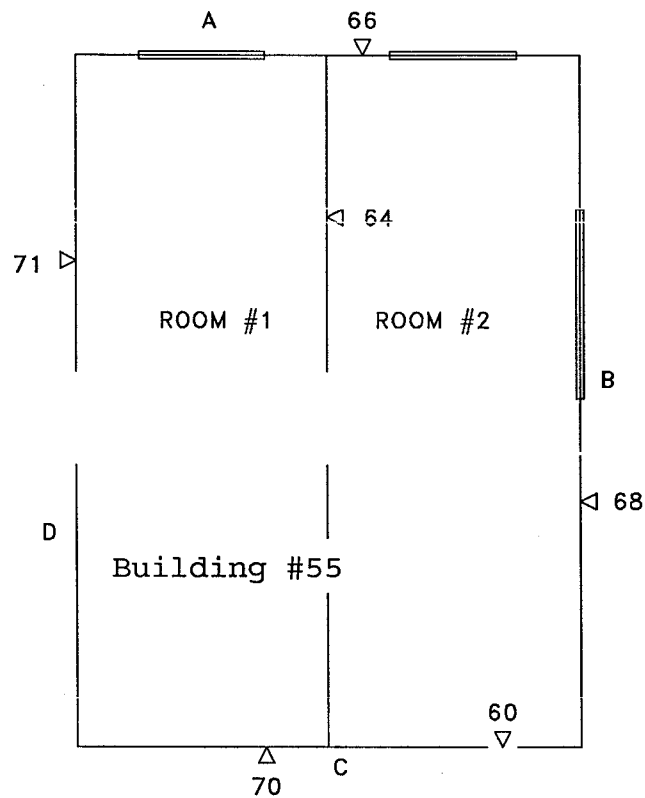
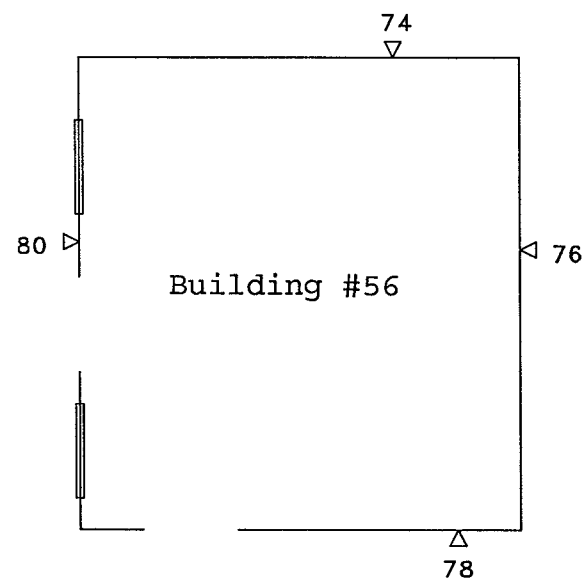
FLOOR PLAN

POSITIVE LEAD BASED PAINT (LBP) SAMPLE LOCATION

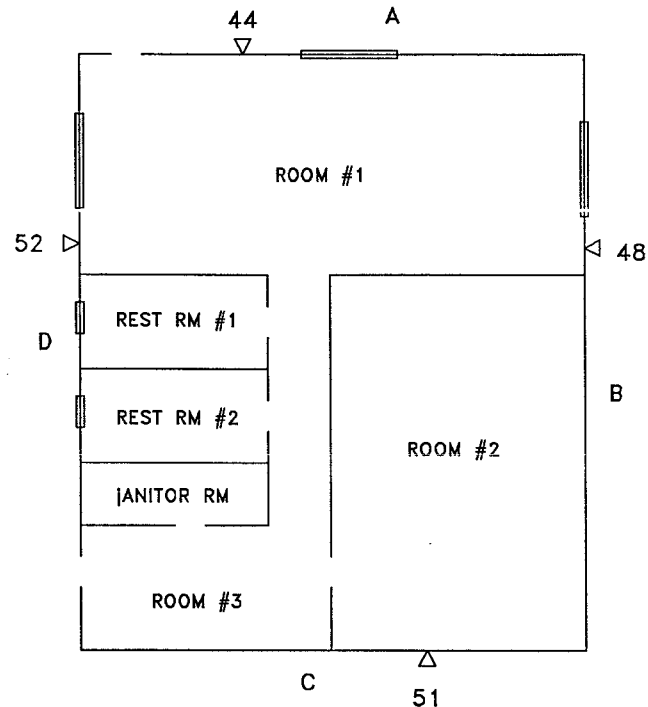
FLOOR PLAN
Building #54

POSITIVE LEAD BASED PAINT (LBP) SAMPLE LOCATION
